# **Methamphetamine and Ecstasy (MDMA) Assessment**

## Re: Methamphetamine and Ecstasy (MDMA) Assessment & Testing

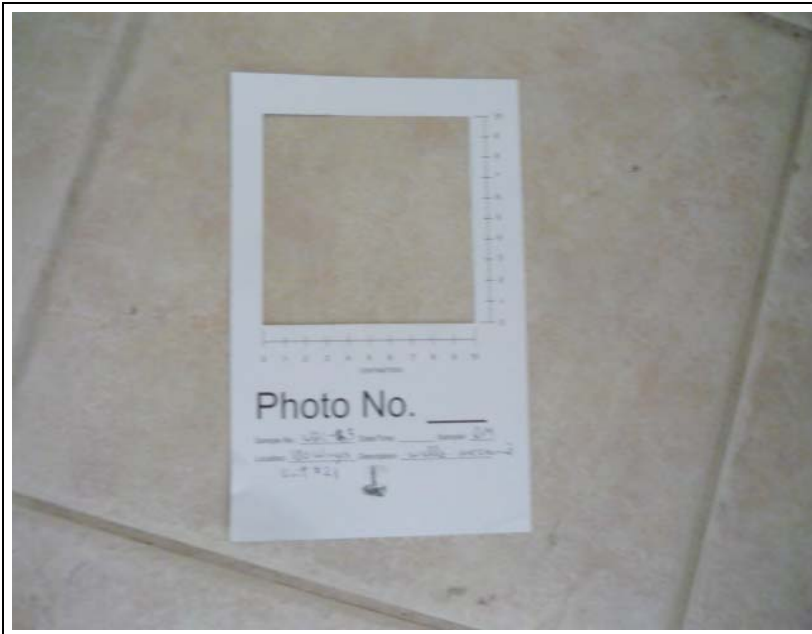
**Figure 5:**

Photo of swab sample U21-3, located in the kitchen and south office on ceramic floor tiles, counter top, and drywall walls (4 composite samples) in Unit 21.

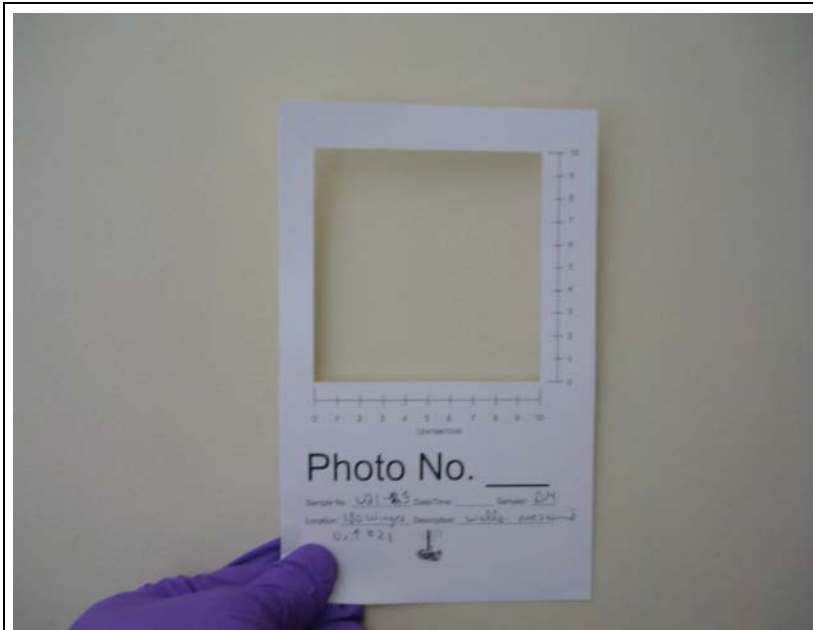
**Figure 6:**

Photo of swab sample U21-3, located in the kitchen and south office on ceramic floor tiles, counter top, and drywall walls (4 composite samples) in Unit 21.

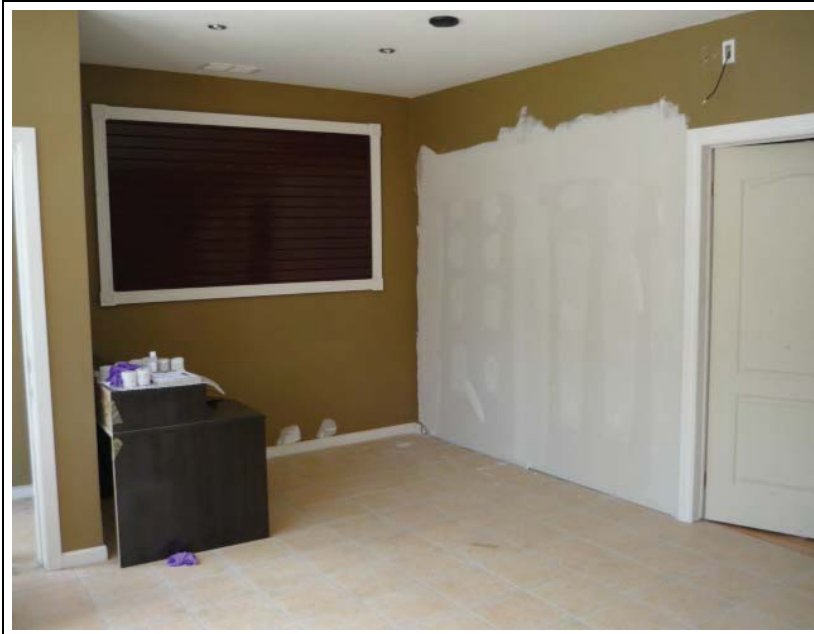
**Figure 19:**

Photo of the reception area located in Unit 22 (Ecstasy Lab).

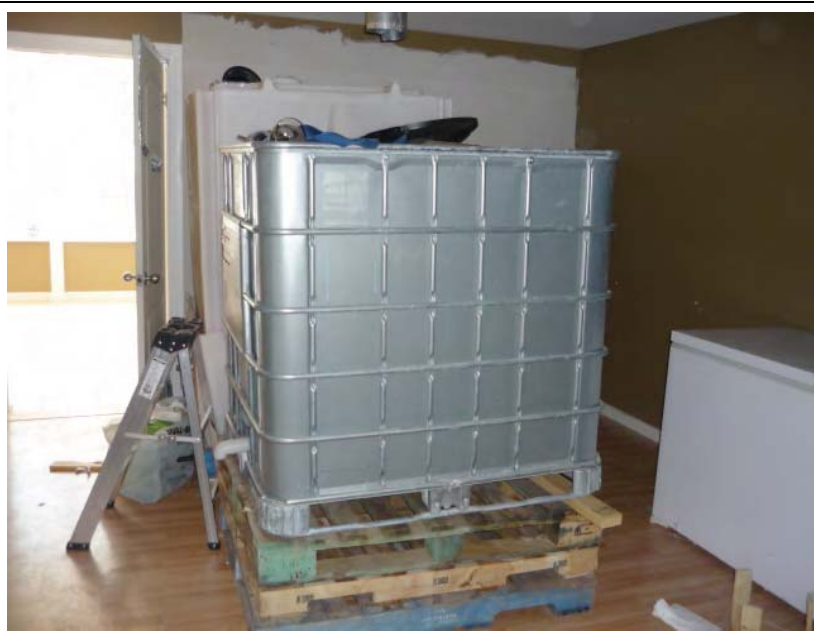
**Figure 20:**

Photo the south office showing two (2) storage tanks and one (1) freezer that were used for the production of ecstasy (Unit 22 - Ecstasy Lab).

- 3) Remove and discard all ecstasy manufacturing equipment consisting of flex duct venting, freezers, tanks, totes, pails, polyethylene tubing, vent motors, venting, burners, propane tanks, ceiling fans, roof venting, and ecstasy waste (hazardous material waste removal).

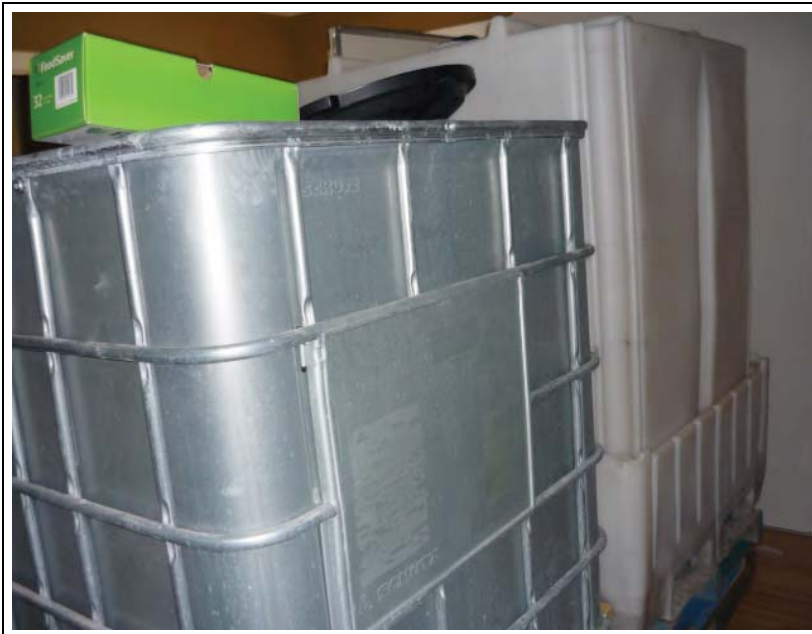
**Figure 21:**

Photo the south office showing two (2) storage tanks and one (1) freezer that were used for the production of ecstasy (Unit 22 - Ecstasy Lab).

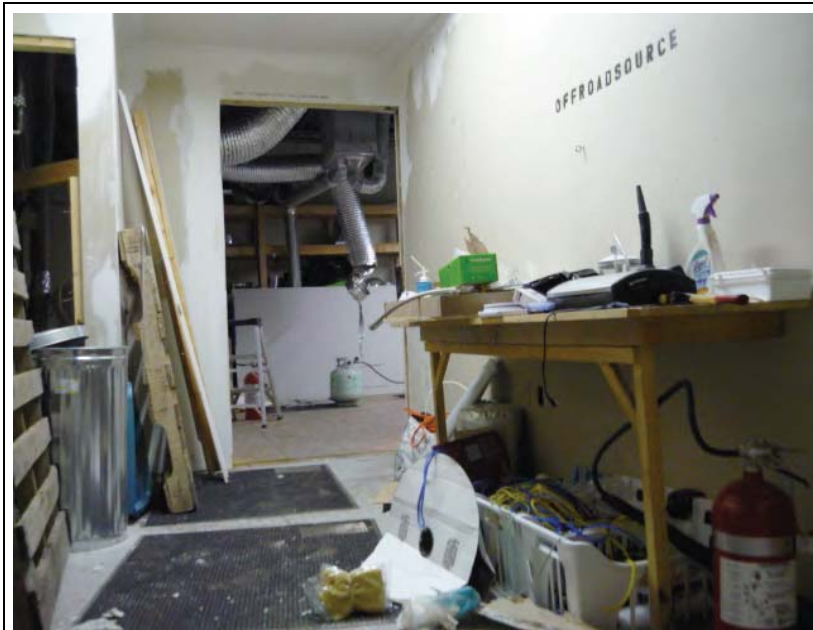
**Figure 22:**

Photo of the mezzanine area of Unit 22 showing ecstasy manufacturing equipment.

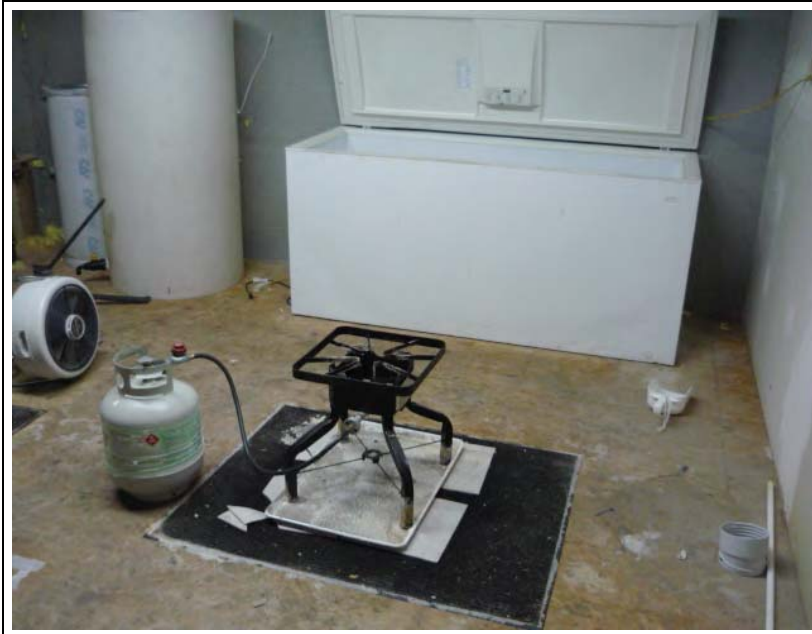
**Figure 23:**

Photo of the mezzanine area of Unit 22 showing ecstasy manufacturing equipment in the “cook area”.

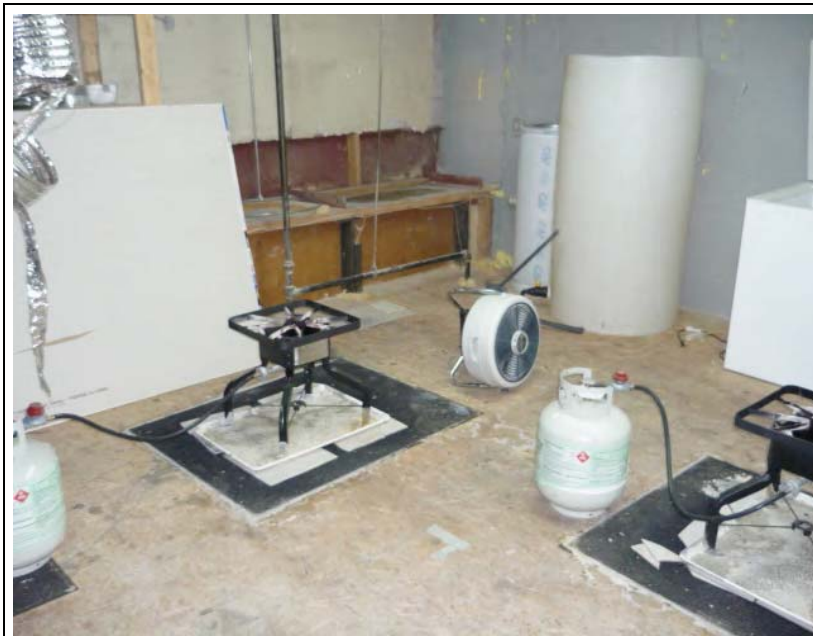
**Figure 24:**

Photo of the mezzanine area of Unit 22 showing ecstasy manufacturing equipment in the “cook area”.

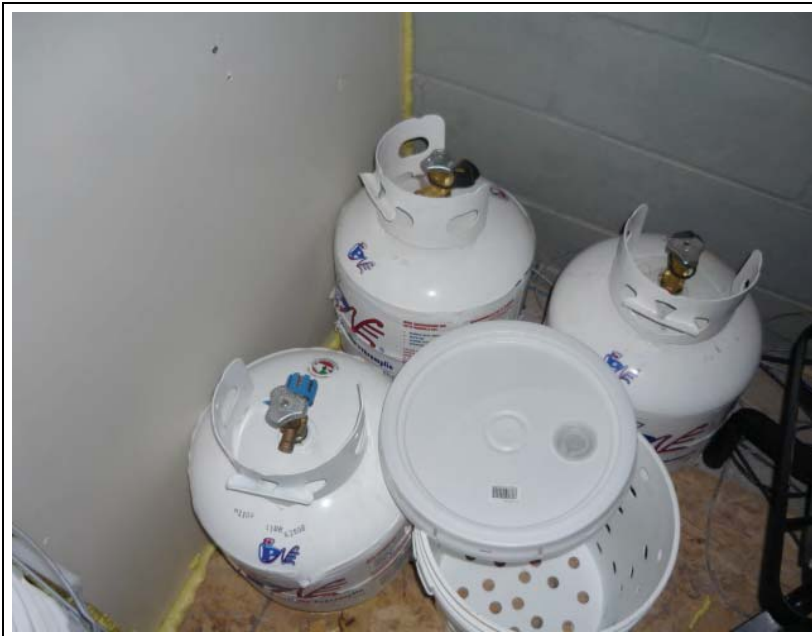
**Figure 25:**

Photo of the mezzanine area of Unit 22 showing ecstasy manufacturing equipment in the “cook area”.

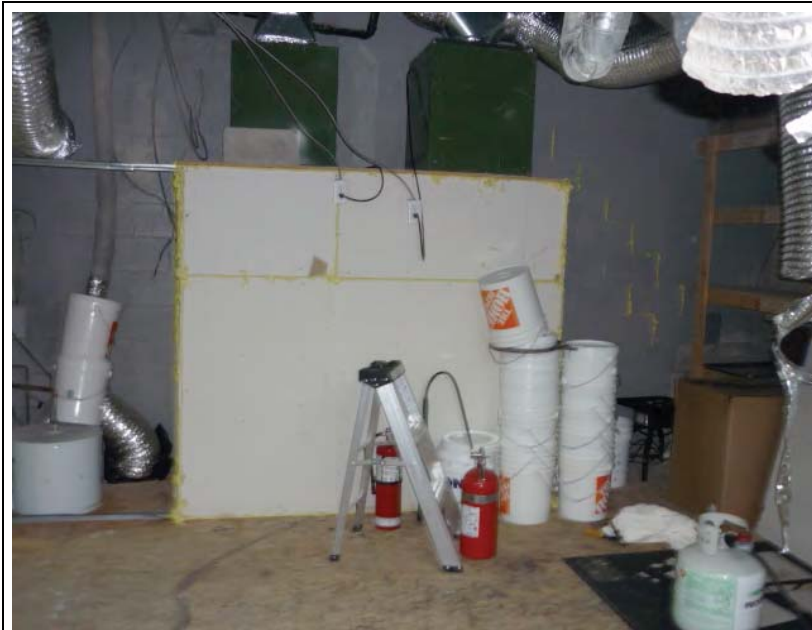
**Figure 26:**

Photo of the mezzanine area of Unit 22 showing ecstasy manufacturing equipment in the “cook area”.

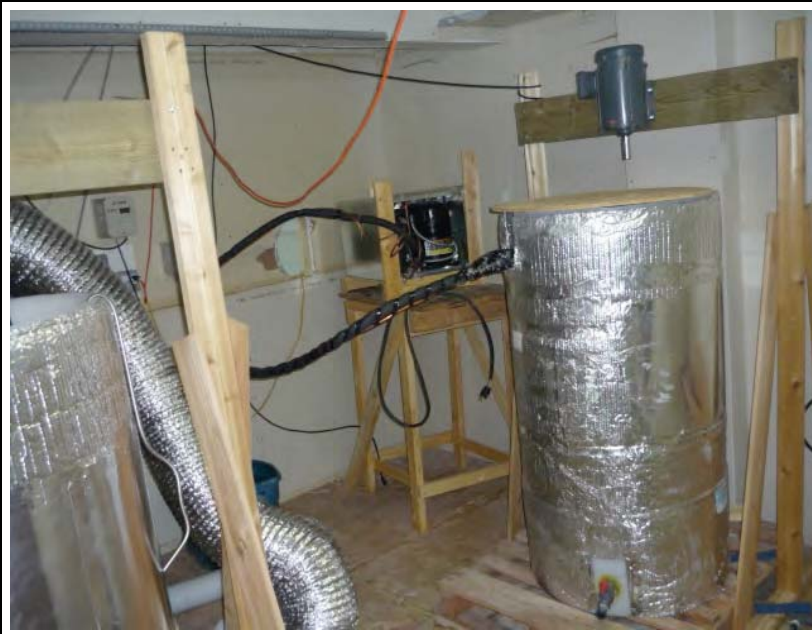
**Figure 27:**

Photo of the mezzanine area of Unit 22 showing ecstasy manufacturing equipment in the “cook area”.

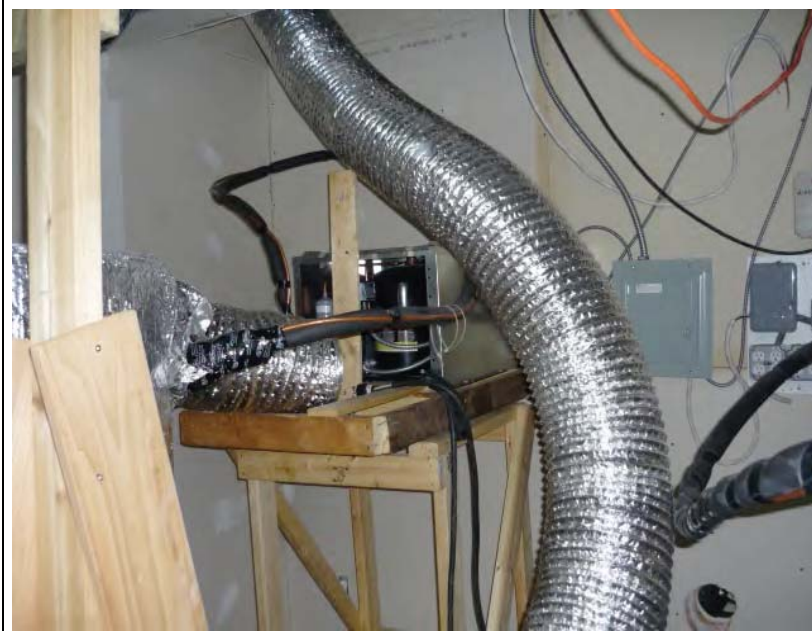
**Figure 28:**

Photo of the mezzanine area of Unit 22 showing ecstasy manufacturing equipment in the “cook area”.

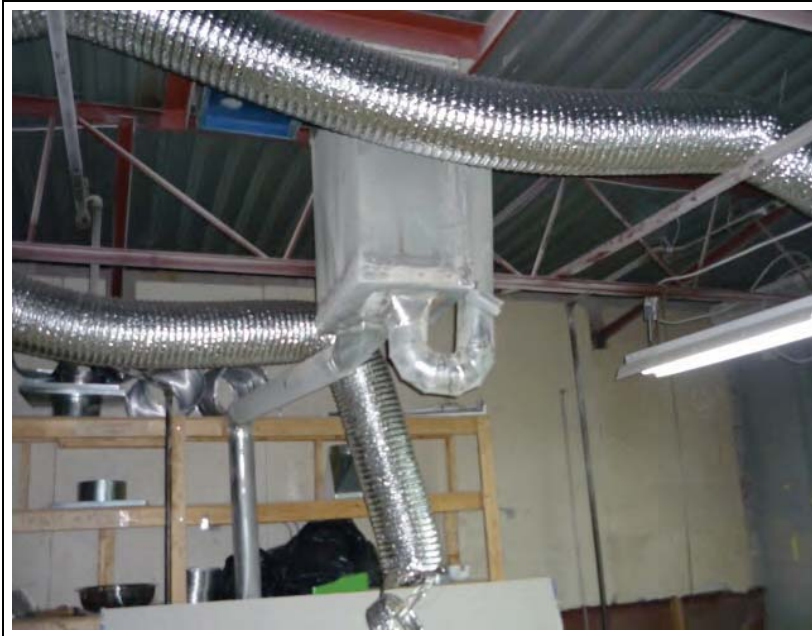
**Figure 29:**

Photo of the mezzanine area of Unit 22 showing ecstasy manufacturing equipment in the "cook area".

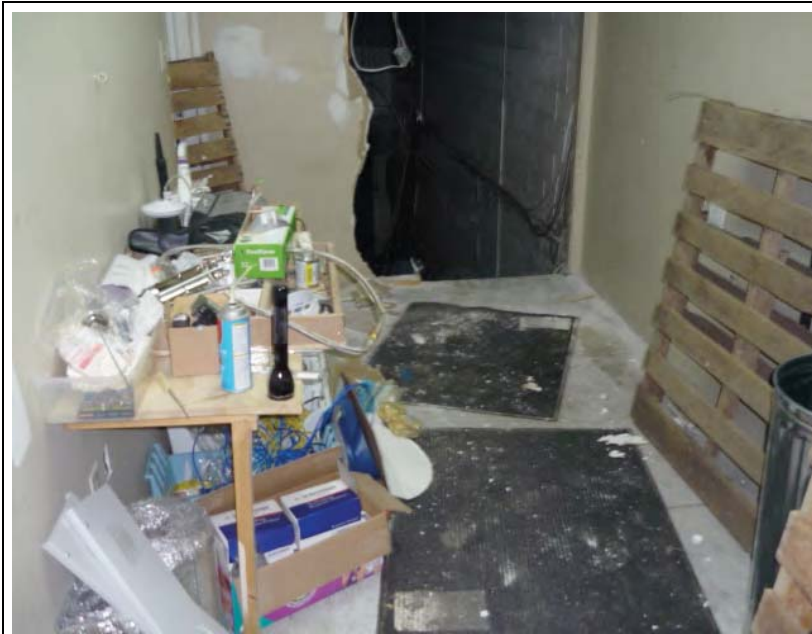
**Figure 30:**

Photo of the mezzanine area of Unit 22 showing ecstasy manufacturing equipment in the "cook area".
